THESIS

THE RESPONSE AND FAILURE MECHANISMS OF
CIRCULAR METAL AND COMPOSITE PLATES
SUBJECTED TO UNDERWATER SHOCK LOADING

March 1990

19. ABSTRACT (continue on reverse if necessary and identify by block number)					
<p>The response and failure mechanism of circular aluminum and S-2 glass fiber/polyester resin matrix composite panels in response to underwater shock loading were investigated. The response of the aluminum panels was compared to the characteristic response of thin circular metal plates subjected to shock loading with a good degree of correlation. The response of the aluminum panels was then used as a reference with which to compare the response of the composite panels.</p> <p>The response and failure mechanism of the composite panels were found to be highly dependent on the boundary conditions of the panel. For the conditions of this test series, in which the panel boundary was allowed limited motion in the radial direction, the response of the composite panel was determined to be generally similar to the response of the aluminum panels, mitigated by the high strength in tension of the glass fiber. The failure mechanism appeared to be localized matrix failure in compre

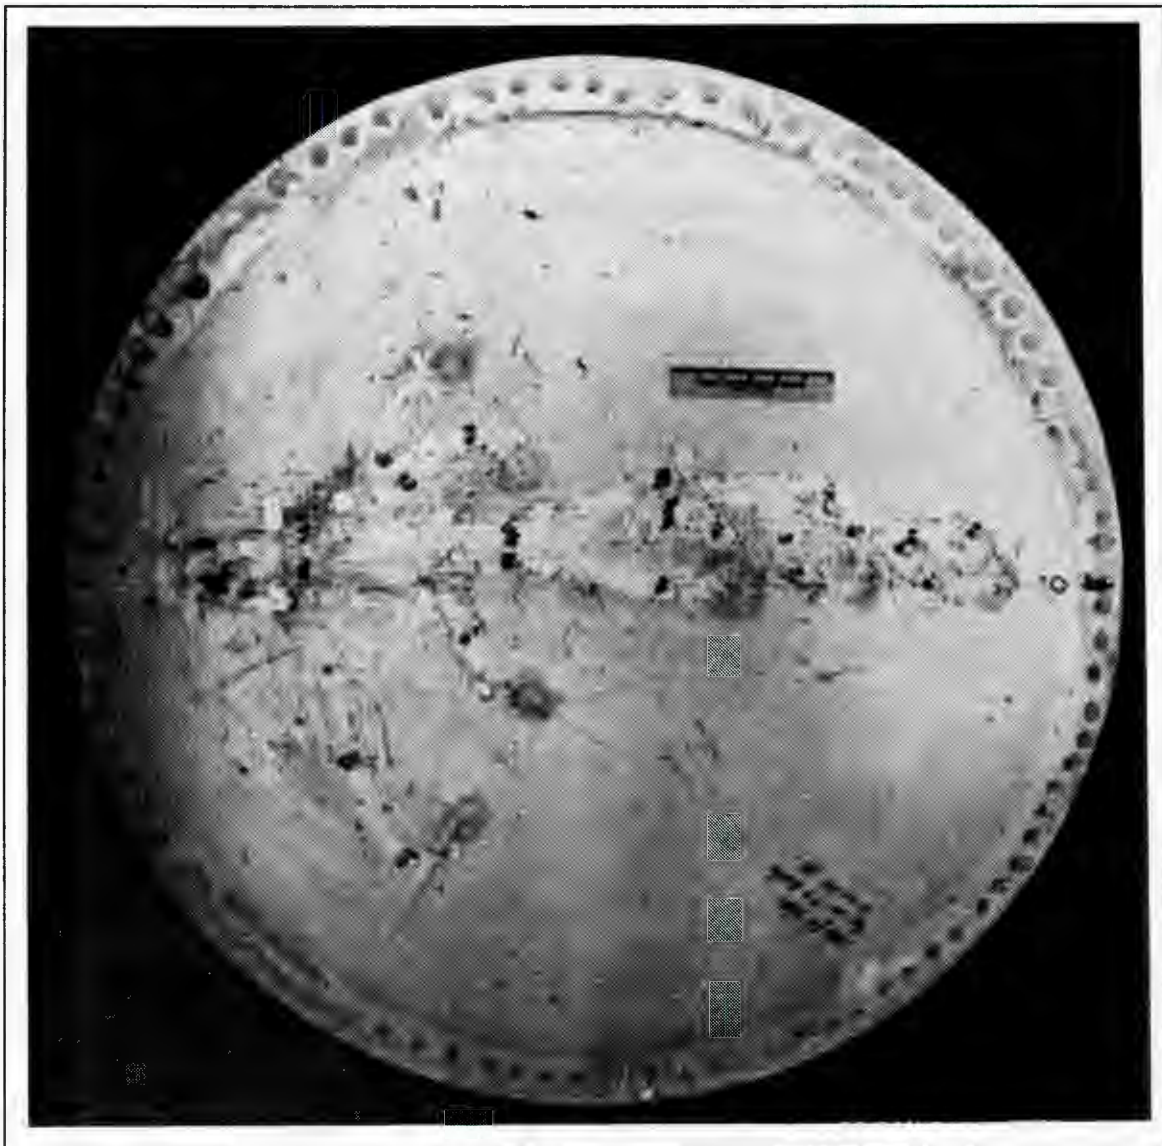
Figure 24. The Aluminum Panel From Test T1W.

The water backed test panels showed little or no damage from the underwater explosions regardless of the charge weight used. As shown by Figure 24 the aluminum plate of test T1W was unaffected by the shock wave produced by five pounds of TNT. No noticeable deformation was noted in the composite plates subjected to the shock from five pounds of TNT in test T2W and to the shock from ten pounds of TNT in test T3W. The

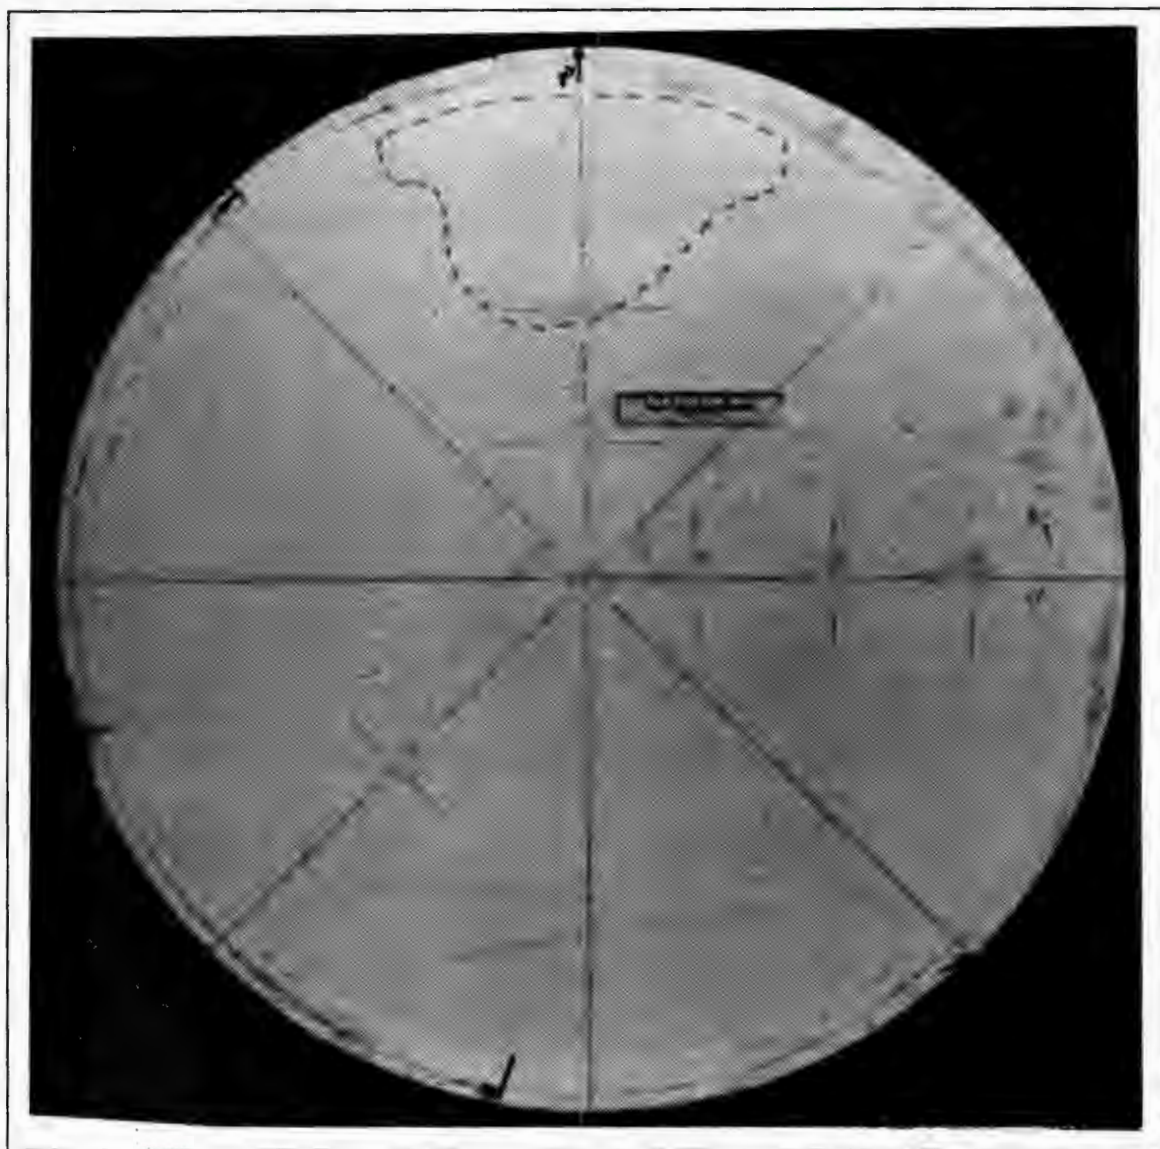
Figure 25. The $[0^\circ/90^\circ/0^\circ/90^\circ/0^\circ]_s$ Composite Panel From Test T2W.

most significant effect on the water backed panels was noted in the composite panel from test T2W. A crescent shaped internal delamination located at the top of the panel was visible when the panel was back lighted. From the shape and location of the delamination, it appeared to have been caused by a trapped air bubble behind the panel that allowed that section of the panel to flex more than the water supported sections surrounding it. The water backed test fixture vents that were supposed to allow air to escape from behind the test panel were carefully inspected and verified clear prior to test T3W. No delaminations were found in the composite panel following that test even though a ten pound charge was detonated. The composite panels used in test T2W and T3W are shown in Figure 25 and Figure 26.

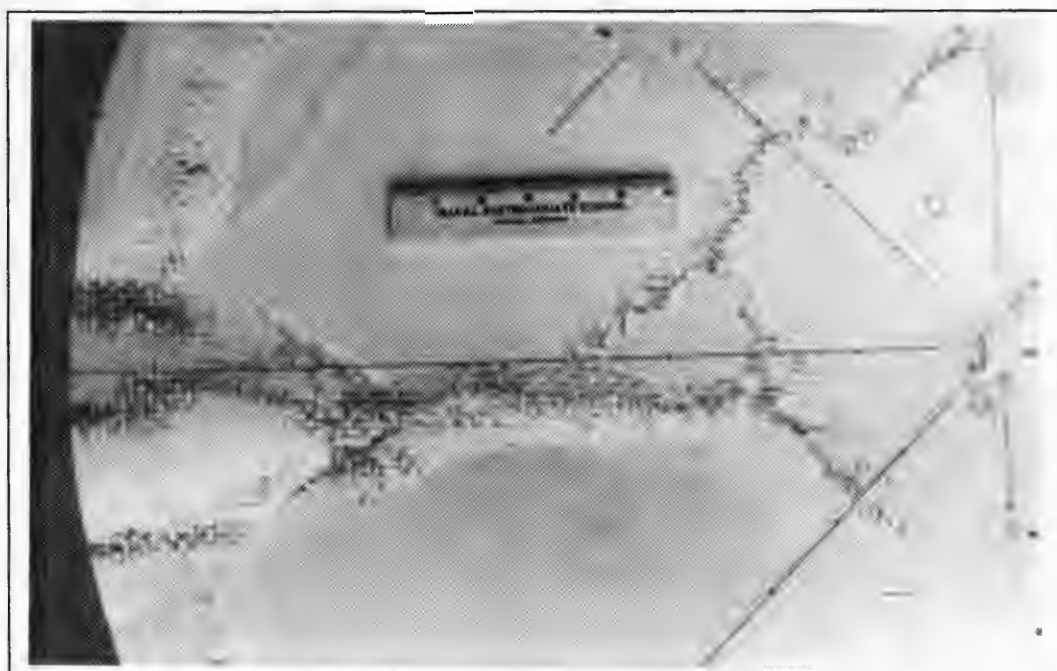
Figure 48. The Composite Panel From Test T3A.

Figure 49. Detail of the Left Quarter of the Panel From T3A.

Figure 50. Detail of the Lower Quarter of the Panel From T3A.

Figure 51. Detail of the Right Quarter of the Panel From T3A.

As shown in the detailed photographs found in Appendix B of the damaged areas, glass fiber breakage in all of the composite panels was minimal. The primary locations for fiber breakage were on the panels from T3A and T4A-2 where the composite panels were constrained from bending by the portion of the panel that stayed within the clamp rings. A small amount of breakage was also found at the outer end of the radial matrix failures on the panels used for the five pound charge air backed tests.

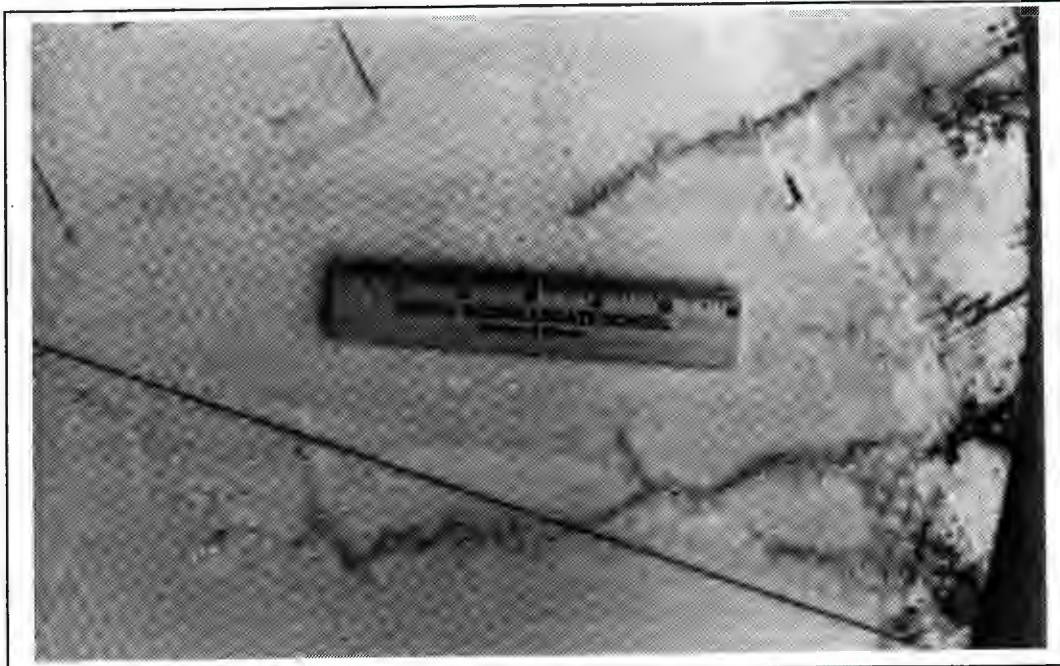
Figure 55. The Composite Panel From Test T4A-2.

Figure 56. Detail of the Left Quarter of the Panel From T4A-2.

Figure 57. Detail of the Lower Right Quarter of the Panel From T4A-2.

Figure 58. Detail of the Upper Right Quarter of the Panel From T4A-2.
